**COMPREHENSIVE NESHAP
ASBESTOS SURVEY**

FORMER COMMERCIAL BUILDING

*112 W. Madison Street
Ottawa, IL 61350*

MEC PROJECT #: 14-01-015-INSP

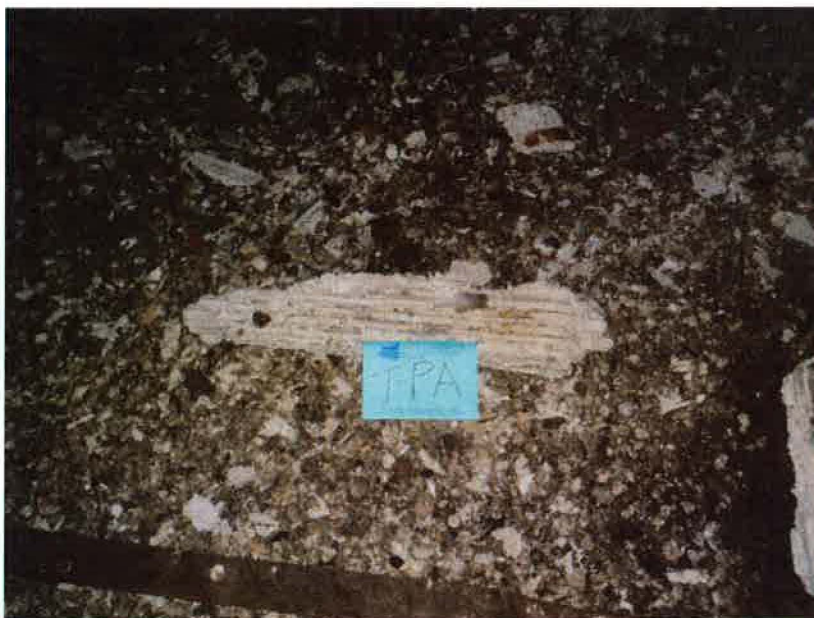
Homogeneous Area:	TPA
Material Description:	Air Cell Pipe Insulation/Debris
Location:	Basement Through 5 th Floor – Throughout
ACM Y/N:	Yes

Comments: Visible Debris Throughout – All Floors – Heaviest in Basement
Entire Floor & Items on it Contaminated.

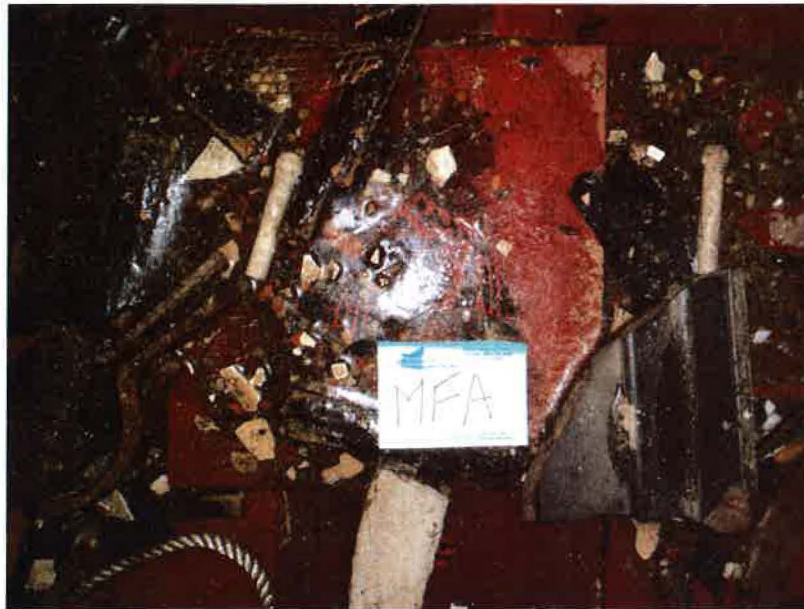
Homogeneous Area:	MFA
Material Description:	12x12 Floor Tile/Mastic – Red
Location:	5 th Floor – Throughout
ACM Y/N:	Yes

Comments: Tile Covered over with Debris – Over Positive Leveling Compound (MMH) on Wood Both Tile & Mastic Positive for ACM.

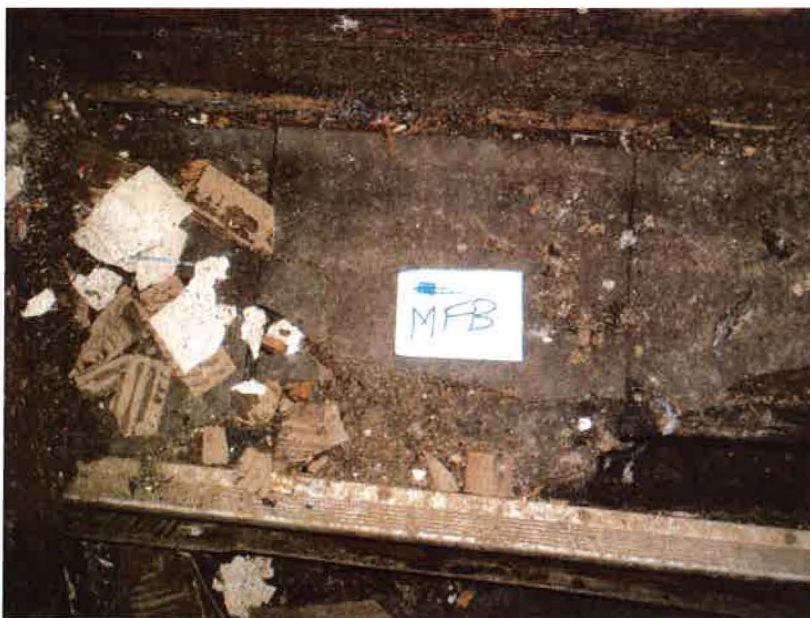
Homogeneous Area:	MFB
Material Description:	12x12 Floor Tile/Mastic – Brown
Location:	Stairs 1 st – 5 th Floor
ACM Y/N:	Yes

Comments: Tile covered with debris – Over positive leveling compound
On wood. Both Tile & Mastic Positive for ACM.

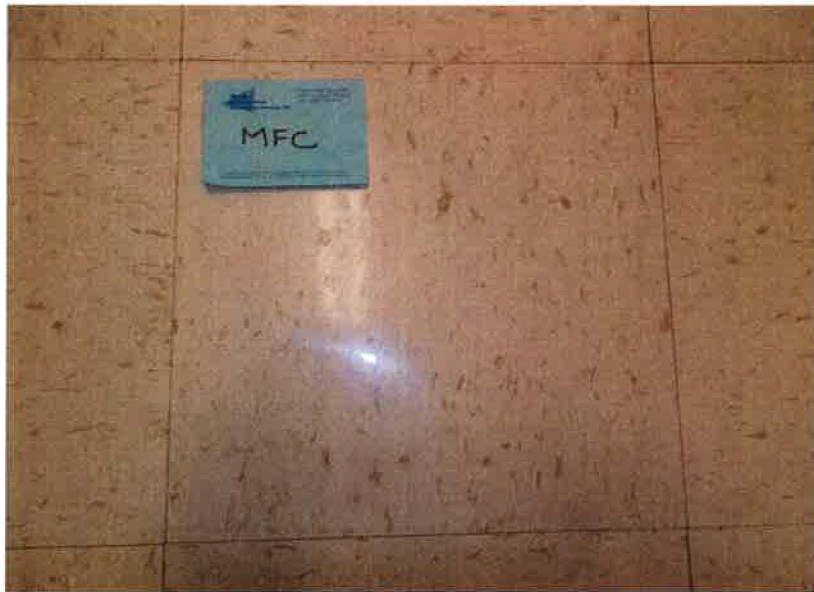
Homogeneous Area:	MFC
Material Description:	12x12 Floor Tile/Mastic – Cream w/Tan Specks
Location:	2nd Floor Stairwell Landing
ACM Y/N:	Yes

Comments: Tile is Positive for ACM. Mastic is Negative for ACM.

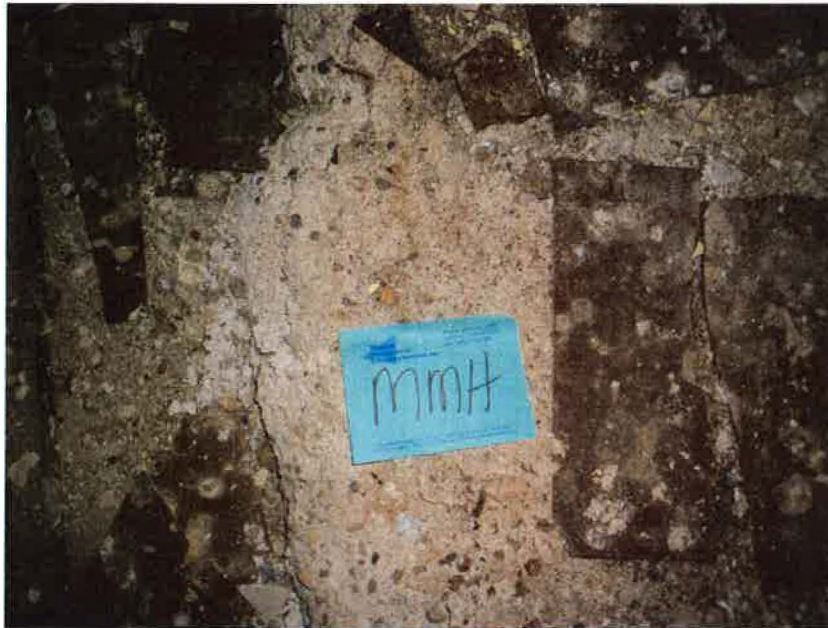
Homogeneous Area:	MMH
Material Description:	Leveling Compound
Location:	1 st – 5 th Floors – Throughout
ACM Y/N:	Yes

Comments: Under Floor Tile on Wood.

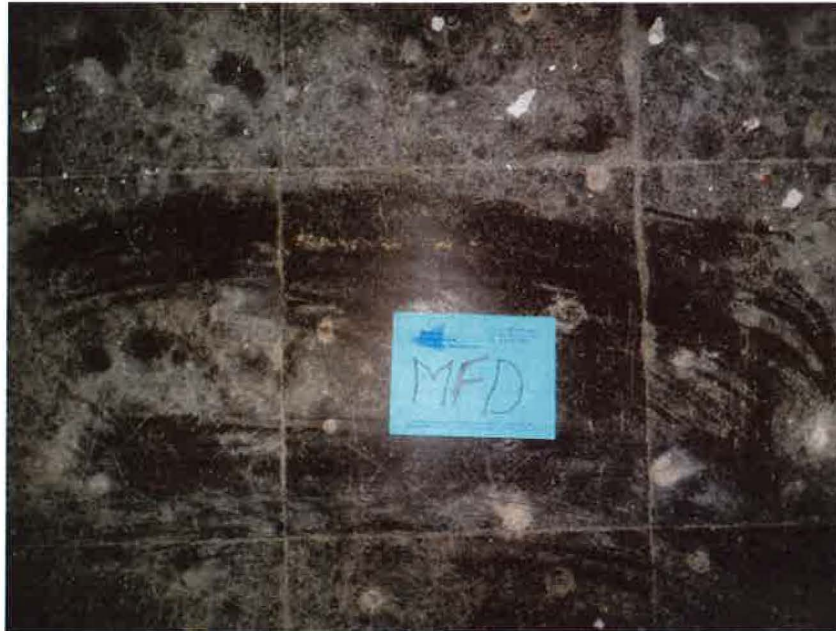
Homogeneous Area:	MFD
Material Description:	9x9 Floor Tile/Mastic – Dark Brown
Location:	3 rd Floor – Throughout
ACM Y/N:	Yes

Comments: Tile Covered Over with Debris – Over Positive Leveling Compound on Wood. Both Tile & Mastic Positive for ACM.

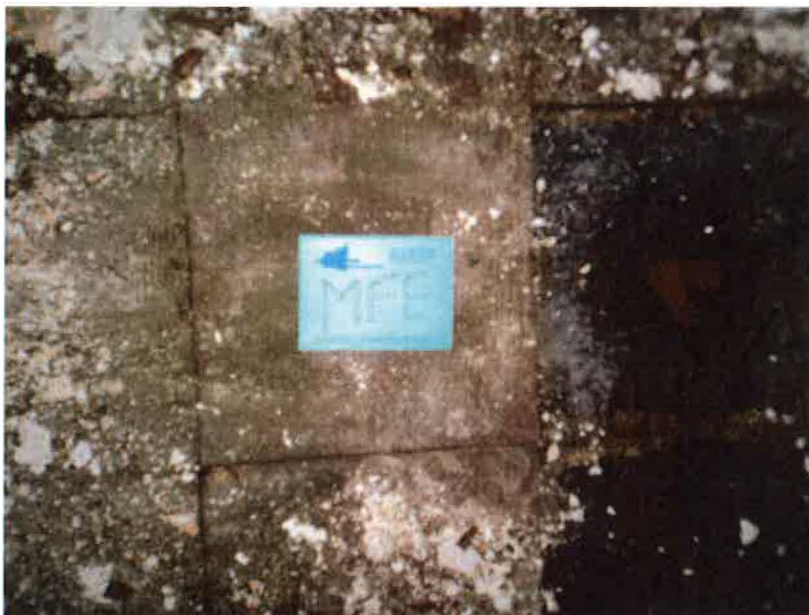
Homogeneous Area:	MFE
Material Description:	9x9 Floor Tile/Mastic – Tan
Location:	2 nd Floor – Throughout
ACM Y/N:	Yes

Comments: Tile Covered Over with Debris – Over Positive Leveling Compound on Wood. Tile – Positive, Mastic - Negative.

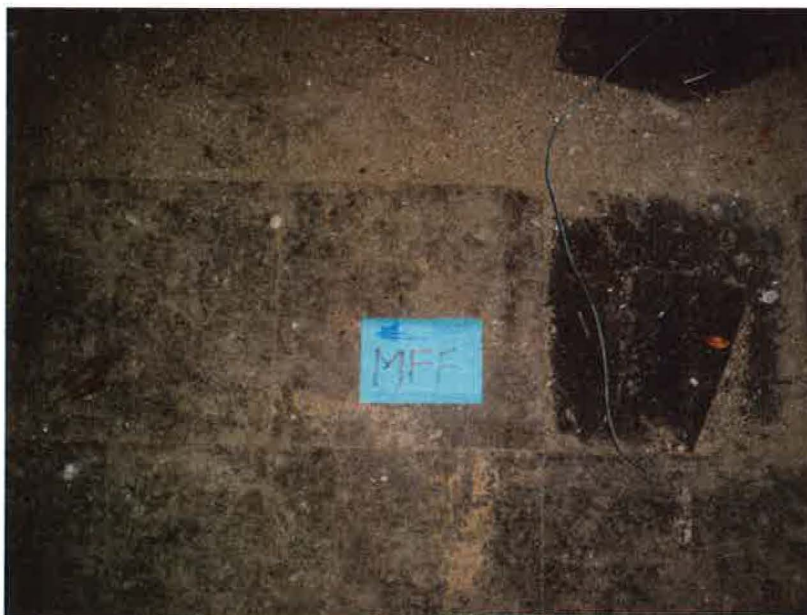
Homogeneous Area:	MFF
Material Description:	9x9 Floor Tile/Mastic – Black
Location:	1 st Floor – Throughout
ACM Y/N:	Yes

Comments: Tile Covered Over with Debris – Over Positive Leveling Compound on Wood & Concrete. Both Tile & Mastic are Positive for ACM.

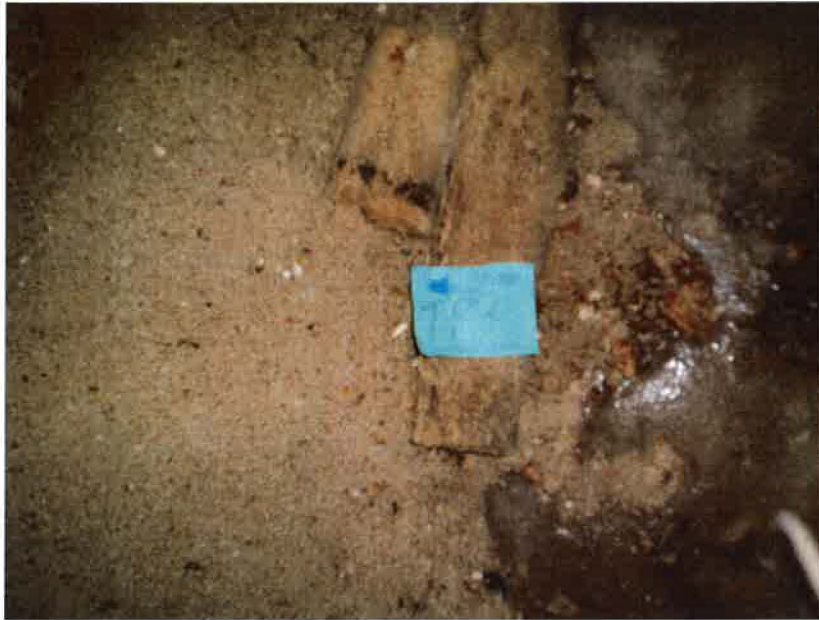
Homogeneous Area:	TPB
Material Description:	Layered Paper Pipe Insulation/Debris
Location:	2 nd Floor – In Walls & Above Ceiling
ACM Y/N:	Yes

Comments: Debris Quantity Included with TPA.

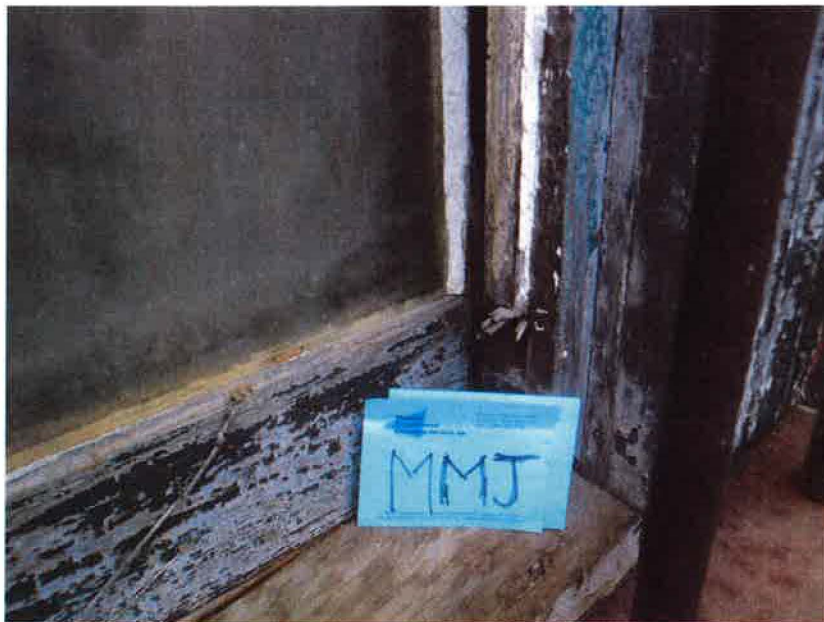
Homogeneous Area:	MMJ
Material Description:	Exterior Window Glazing
Location:	Exterior Windows
ACM Y/N:	Yes

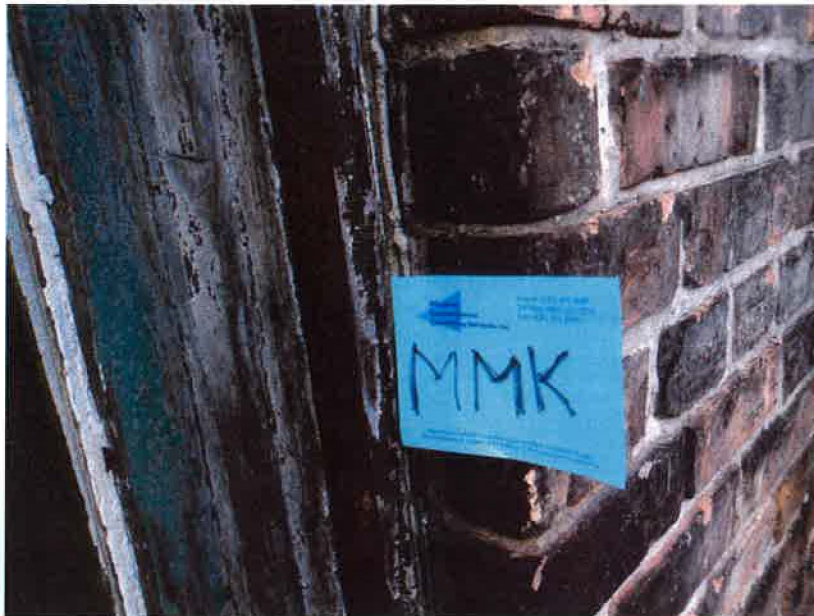
Homogeneous Area:	MMK
Material Description:	Exterior Window Caulking
Location:	Exterior – Original Windows
ACM Y/N:	Yes

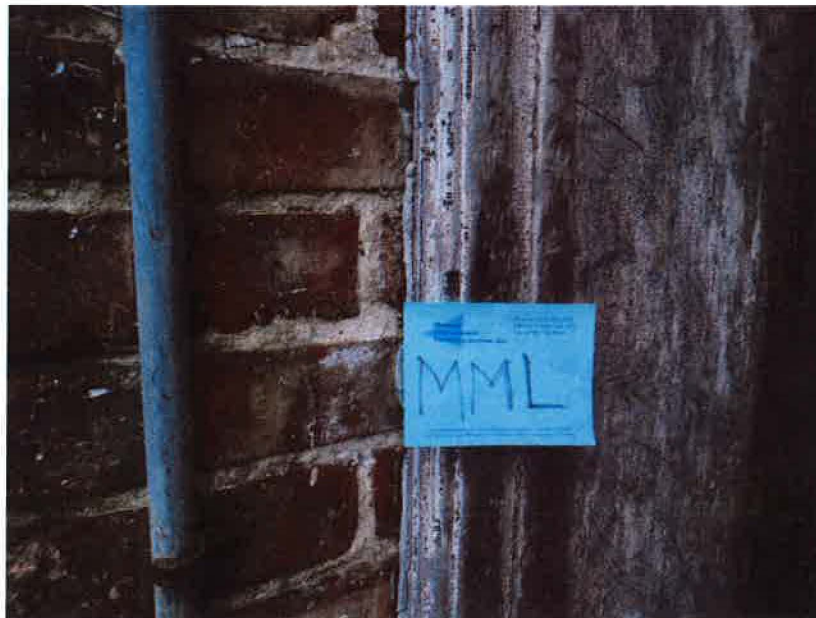
Homogeneous Area:	MML
Material Description:	Exterior Door Caulking
Location:	Exterior – Front & Back Entrances
ACM Y/N:	Yes

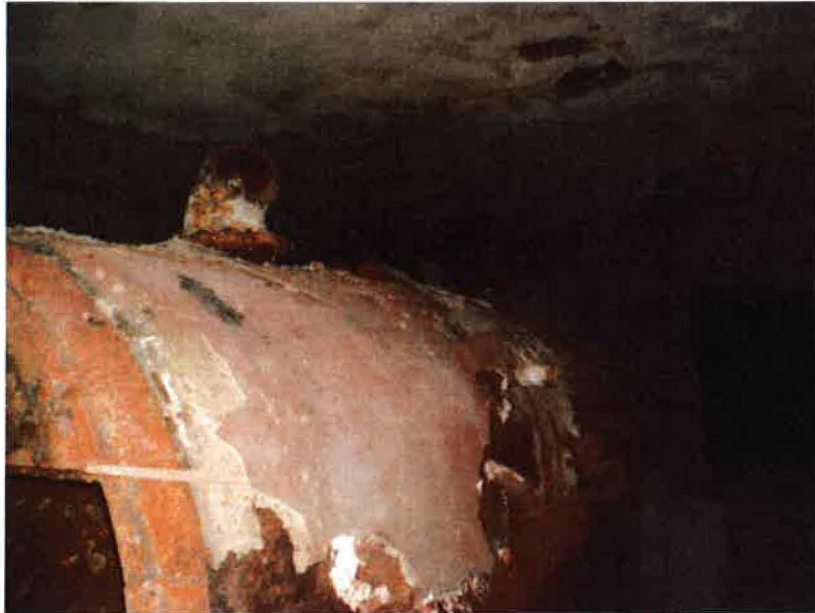
Homogeneous Area:	TTA
Material Description:	Tank Insulation
Location:	Basement
ACM Y/N:	Assumed

Comments: Material is to be Sampled Prior to Design/Abatement.
